No. 1 Frognal Close, London NW3

Frognal Close: listed house refurbishment

Contract value: £600,000
Commenced: January 2003
Completed: 2005

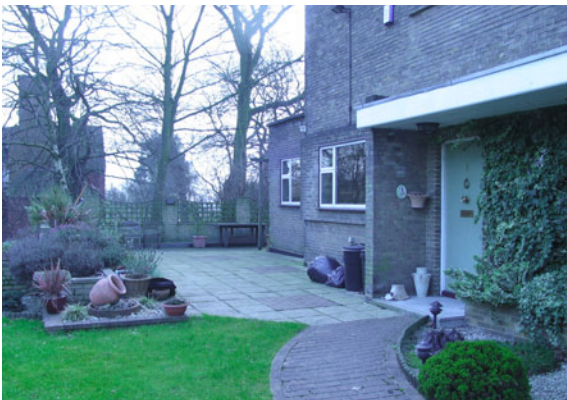
Poor quality hard landscaping materials, 2003

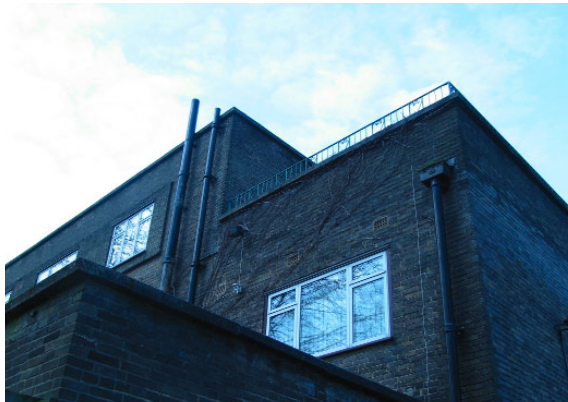
Rear elevation: flue and vines were removed

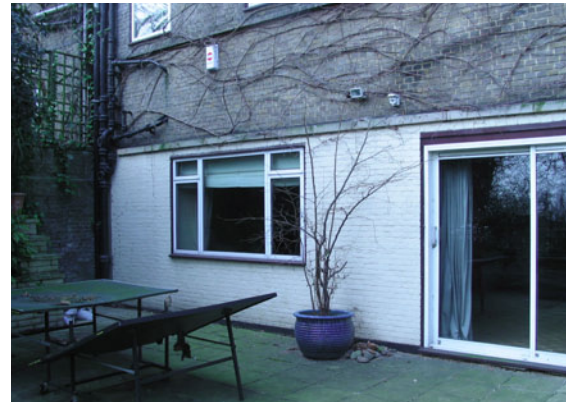
Rear elevation prior to cleaning and paint stripping

The brickwork had been locally repointed which resulted in an uneven appearance. Some areas had been painted, which need to be stripped.

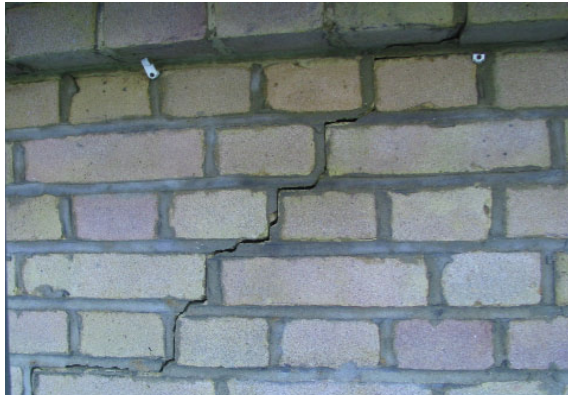
Existing cracks visible after cleaning (north elev)

There are no movement joints in the building, and there were therefore some cracks due to thermal movement, and possibly also settlement due to some nearby trees, which were removed on the structural engineer's advice. There were cracks to the internal leaf around lintel bearings, which became apparent during the alteration work; repairs were carried out using Helix stainless steel bars in the mortar joints. The head of the ground floor openings, where new doors were installed, were reinforced with steel plates bolted to the existing concrete lintel to support the nib of facing brickwork.

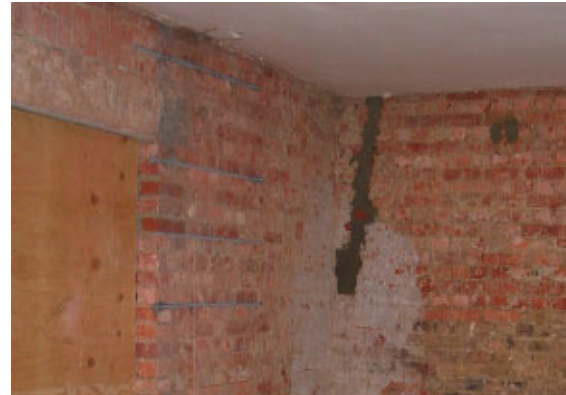
Brickwork repair internally (Helix bars)

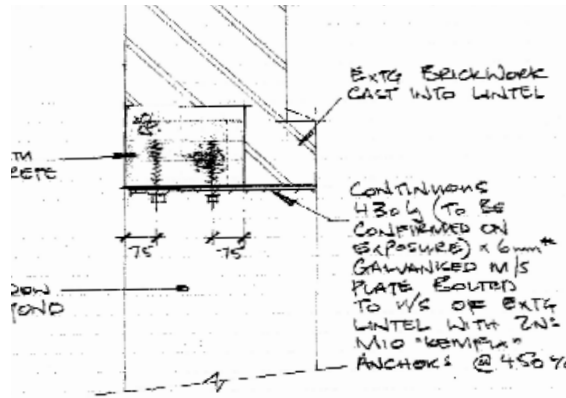
SE's details of window head reinforcement

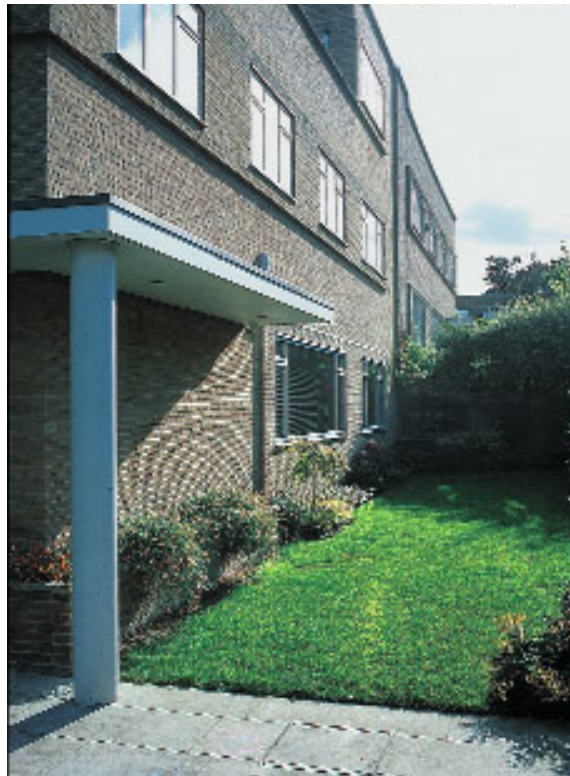
Reconstructed canopy and repointed brickwork

The original brick had become very dirty from air pollution over the previous 70 years. Through discussion with English Heritage about the importance of clean brickwork to the image of modernity that was intended in the original design, we obtained listed building consent for cleaning the brickwork with a light acid wash. A proprietary product containing hydrofluoric acid was used, washed off with water. The brickwork was also treated for efflorescence, and to kill plant growth. Tests were carried out prior to treatment of the whole building, to enable the degree of cleaning to be agreed. The process was carried out under carefully controlled conditions to ensure that the brickwork was all subject to the same process. Repointing was then carried out using a mortar to match the existing, with a buff coloured sand. The joints were lightly recessed to set off the crisp arrises of the bricks.

The red hardwood sub-frames and cills were painted with a colour to match the brickwork, and the sloping cement fillet to the top of the projecting brick bands were replaced if necessary and painted with an acrylic paint (Flexicryl).

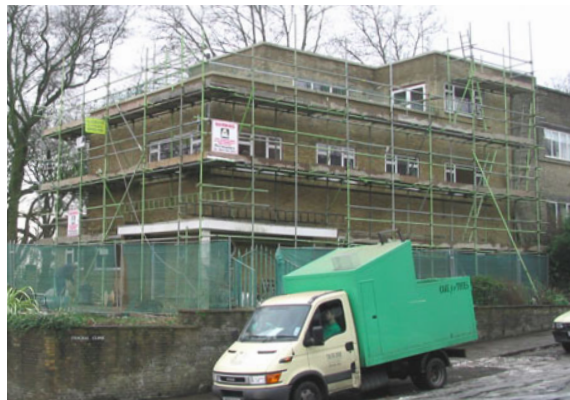
Brickwork cleaning and repair underway

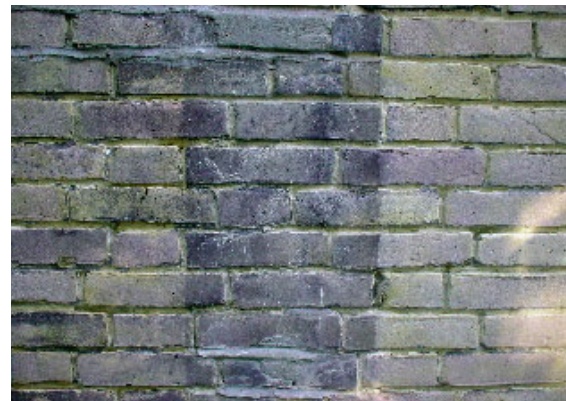
Tests of cleaning carried out

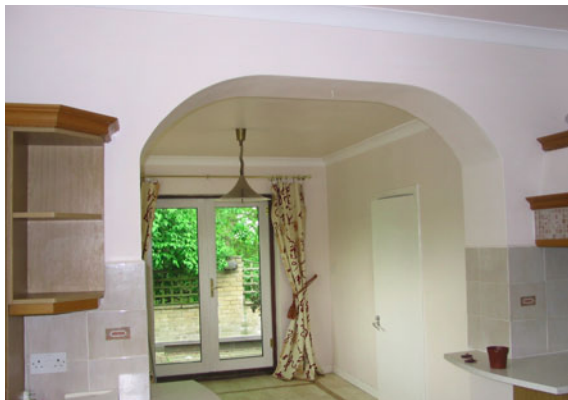
Existing kitchen, with false arch

In the kitchen all fittings were removed, together with the false arch and covings. The non-original larder was removed and a new window opening formed over looking the terrace. A new staircase was created to connect to the basement garage area, where a utility area was located, together with a home office. Waterproofing tanking and the introduction of natural light and ventilation were required to make the basement a habitable space.

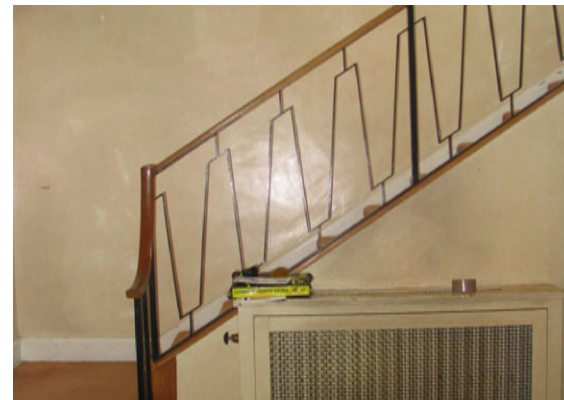
Non-original balustrade

The existing staircase did not appear to be original, and may have been replaced in the 1950s. It was fussily detailed with awkward junctions and was not of sufficient height, and it was therefore proposed to be replaced with a simple glass balustrade.

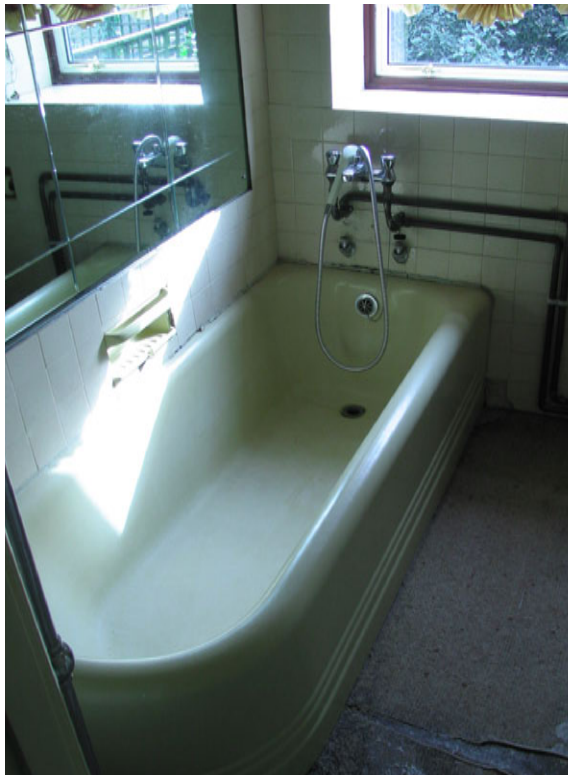
original bath prior to refurbishment

During the refurbishment works the original bath was relocated and re-enamelled (on site). The floor was strengthened in the new location.

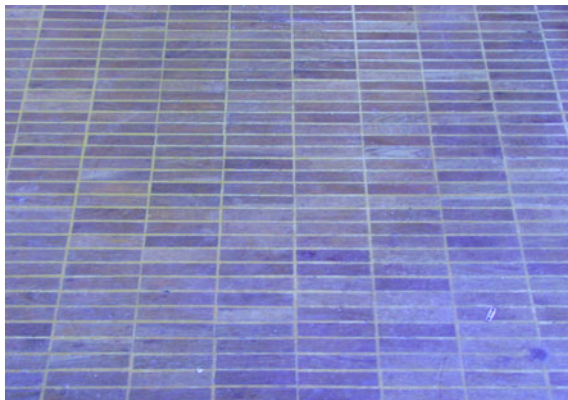
wood mosaic flooring (Living) prior to refurbishment

The wood mosaic flooring extends through all three living rooms, and the hallway, where it had been subject to most wear and tear. There are two different patterns, mostly stack bonded, but in the dining room rotated squares of the three. The individual blocks were 25 x 110mm x 8mm thick, and had 4mm wide joints of grout. In some places the blocks needed to be patch repaired and re-adhered to the screed.

The treatment of the wood mosaic flooring was discussed and samples for repair were carried out. It was decided to minimize the amount of sanding, as this would damage the grout and remove the patina from the face of the timber. The contractor prepared samples using cementitious and epoxy based grouts, which were coloured with pigment to match the colour of the original. Between the different patterns, where the existing wall was removed, an oak strip was set into the depth of the floor screed; this also helped deal with the slight change in level between the finished floor levels in the two previously separate rooms.

The surface of the timber was cleaned with a solvent and the whole surface treated with Osmo's Polyx hardwax oil.

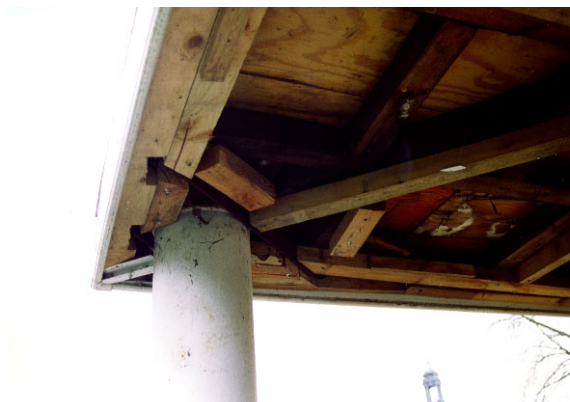
The existing canopy had been clad with UPVC to the sides and soffit, making it appear much thicker than in the original photographs. It had been thought that the canopy may originally have been constructed in concrete, from the appearance in the original photos. On removal of the UPVC cladding however, it was revealed that the canopy was steel framed, bearing on a cast iron column, and infilled with timber studs.

UPVC cladding removed exposing structure

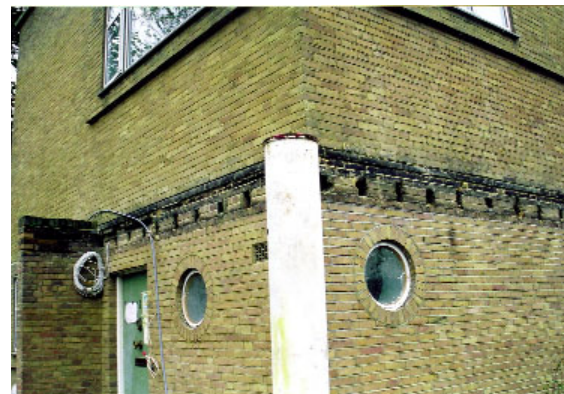
The steelwork was poorly constructed, ie. under-sized, distorted and poorly fixed to the brickwork. It was therefore decided to take down the roof of the canopy and reconstruct it with new steelwork, fixed back to concrete padstones cast into the brickwork. The column was retained, and the existing rainwater pipe that ran through it. The new roofing material is Sarnafil, rather than asphalt, as this is a more durable and less heavy material. The asphalt roof to the second floor level was also renewed with Sarnafil for the same reasons.

Existing canopy removed

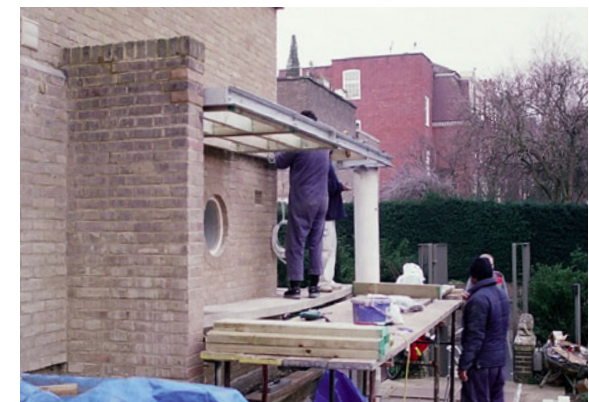
New steel framed canopy under construction
