No. 1 Frognal Close, London NW3

Frognal Close: listed house refurbishment

Contract value: £600,000
Commenced: January 2003
Completed: 2005

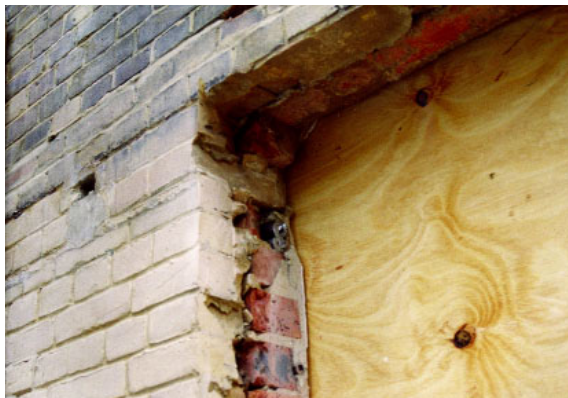
New opening showing facing brickwork and inner skin

There are no movement joints in the building, and there were therefore some cracks due to thermal movement, and possibly also settlement due to some nearby trees, which were removed on the structural engineer's advice. There were cracks to the internal leaf around lintel bearings, which became apparent during the alteration work; repairs were carried out using Helix stainless steel bars in the mortar joints. The head of the ground floor openings, where new doors were installed, were reinforced with steel plates bolted to the existing concrete lintel to support the nib of facing brickwork.

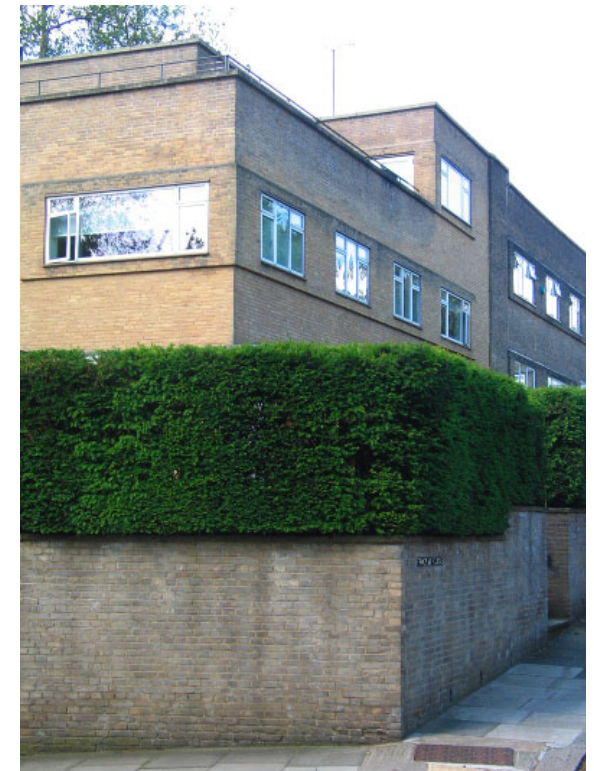
Yew hedge after 9 years growth (2012)

The first phase of the project was to plant a yew hedge in line with the boundary wall, which could be regularly clipped to keep a crisp profile. The opportunity was also taken at this point to fully scaffold the building and to clean, repair and repoint the brickwork.

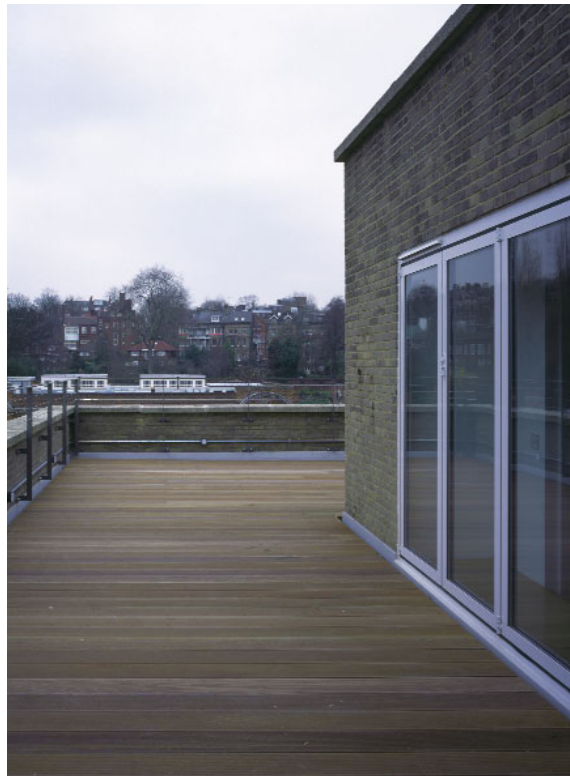
2nd floor terrace, new door opening and balustrade

Access to the external areas was improved by the creation of new door openings at ground and second floor levels, with aluminium sliding-folding doors.

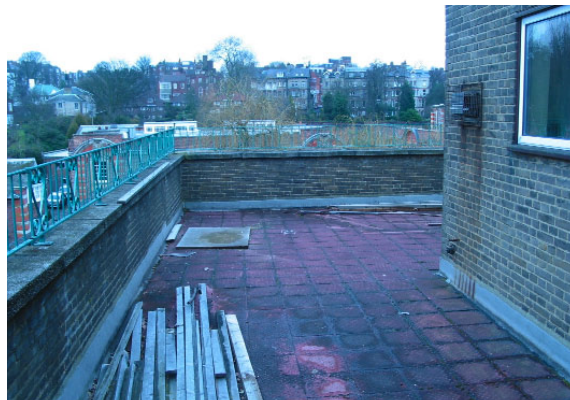
Existing 2nd floor terrace

- Removal of non-original brickwork piers, trellis fencing and wrought-iron railings
- New steel balustrades with stainless steel cable panels to minimise visual impact, to boundary walls and terrace parapets
- new buff sandstone paving to complement colour of the brickwork, laid to rectilinear pattern
- new steel pedestrian and vehicular gates to boundary, finished in mid-grey polyester powder coating
- new hardwood decking.

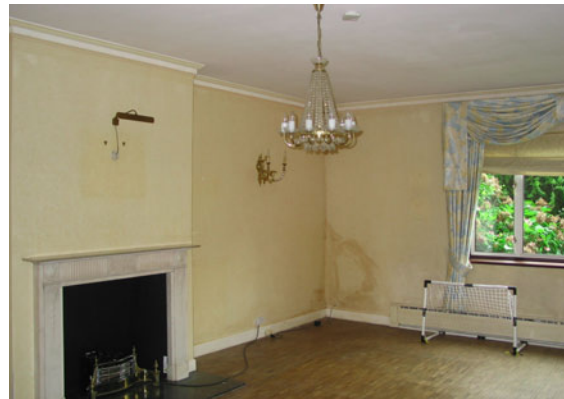
Existing living room, 2003

The house has undergone many changes since it was built in 1937, and some have been inappropriate and out of character with the original building, including the fireplace, staircase balustrade, parapet balustrades, a false arch in the kitchen, ceiling covings and light fittings. All these non-original features were removed and replaced in keeping the modern design aesthetic of the house.

In addition some alterations were made to meet the client's need for a more open living space: the main alterations were connecting the dining and living rooms, increasing the width of door openings to the study and kitchen, and installing sliding doors to avoid the problem of doors opening into each other. The door opening between the room labelled on the original plans as the 'lounge' and 'sitting room' was replaced with a glazed panel (see page 5). When consulted during the listed building consent application process, the 20th Century Society caseworker commented "while this creates a private space for working, it also creates a great deal more connection through the rooms, and creates a lighter more inviting space for the main living space".

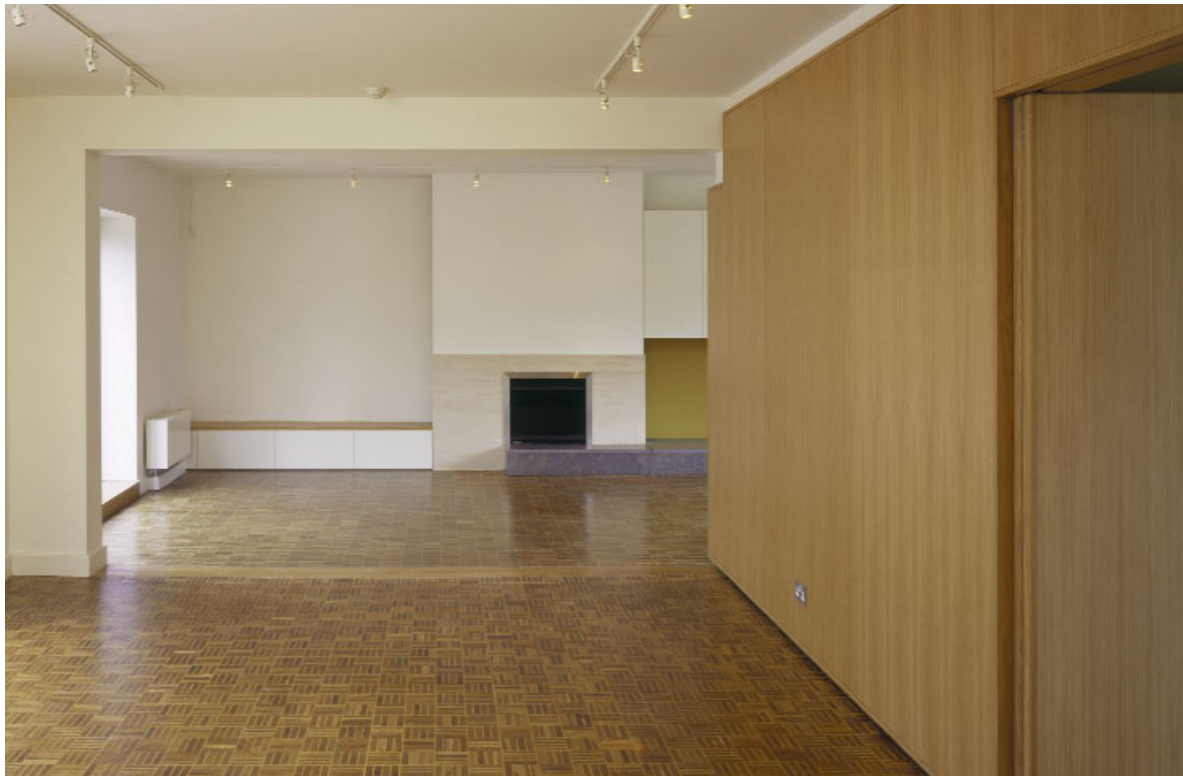
Dining and living rooms connected, with new fire place

The dividing wall between the living and dining rooms has been removed. At the request of the LB Camden's planning officer, a downstand and nib was retained to indicate the original position of the wall. An oak board recessed into the floor also marks the location of the original partition.

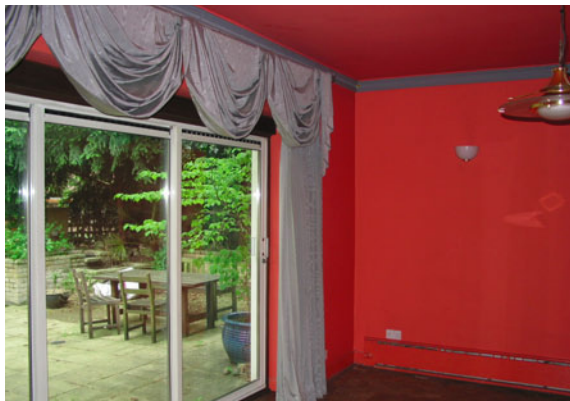
Dining room before works

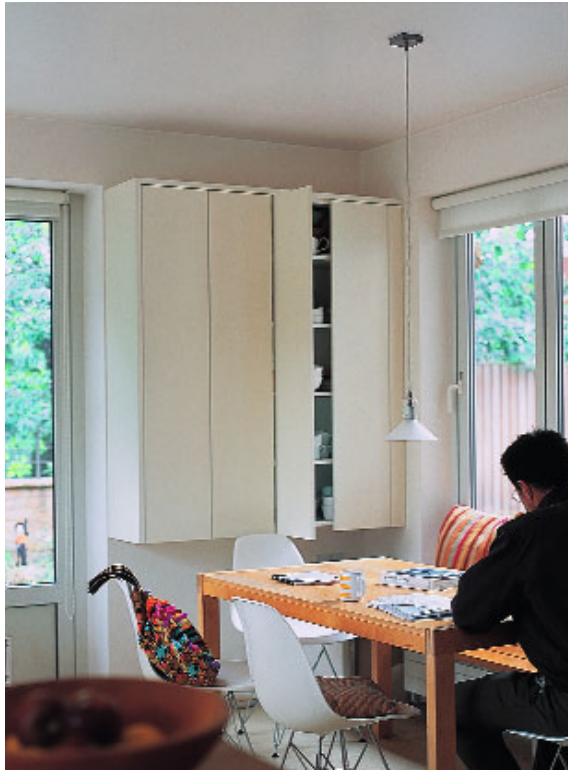
New kitchen door and window to terrace

In the kitchen all fittings were removed, together with the false arch and covings. The non-original larder was removed and a new window opening formed over looking the terrace. A new staircase was created to connect to the basement garage area, where a utility area was located, together with a home office. Waterproofing tanking and the introduction of natural light and ventilation were required to make the basement a habitable space.

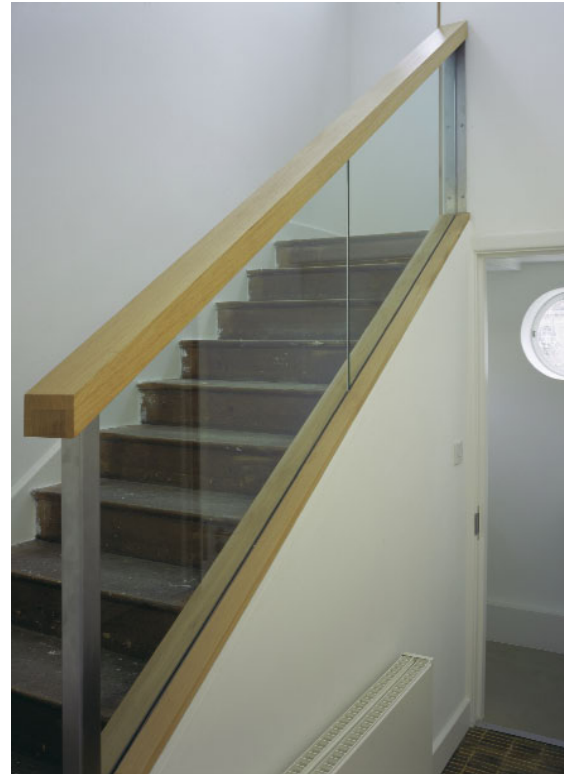
New stair balustrade

The existing staircase did not appear to be original, and may have been replaced in the 1950s. It was fussily detailed with awkward junctions and was not of sufficient height, and it was therefore proposed to be replaced with a simple glass balustrade.

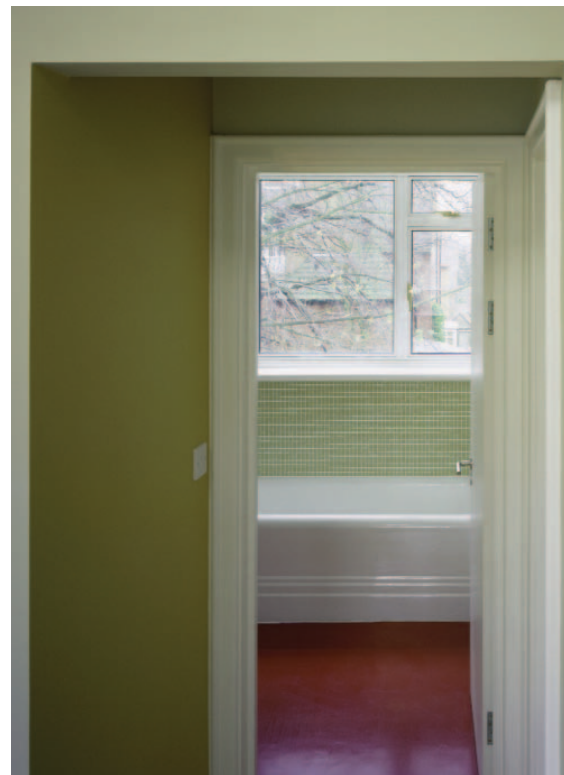
bath re-enamelled, in new location

During the refurbishment works the original bath was relocated and re-enamelled (on site). The floor was strengthened in the new location.
